## EXTENT AND REMEDY ON GULLY EROSION IN BANGSHIKA AREA ADAMAWA STATE, NIGERIA

*A study was carried out in order to obtain sufficient information regarding the severity of soil erosion in Bangshika area. The soil losses in each gully site were evaluated. Representative soil samples in their disturbed forms were collected from each location visited. Soil sample weighing 20 kg each in polythene bags were taken to the laboratory for analysis. Parameters related to soil erodibility were determined, these includes erodibility index, mechanical analysis, organic matter contents, permeability of the soils, soil structure, and aggregate stability. The results show that the area is prone to erosion. The bulk density, particle density and percentage pore space were found to be 332.4 kg/m<sup>3</sup>, 418.6 kg/m<sup>3</sup> and 20.60 % respectively. The volumes of soil loss in the gullies range from 697 to 3362 m<sup>3</sup> in Dilguda and Gulang Nduson. The slope 5 – 10 % in study area is generally undulating. Soil aggregate stability is from 6.4 to 23 MJ in Dilguda and Mugadiji.*

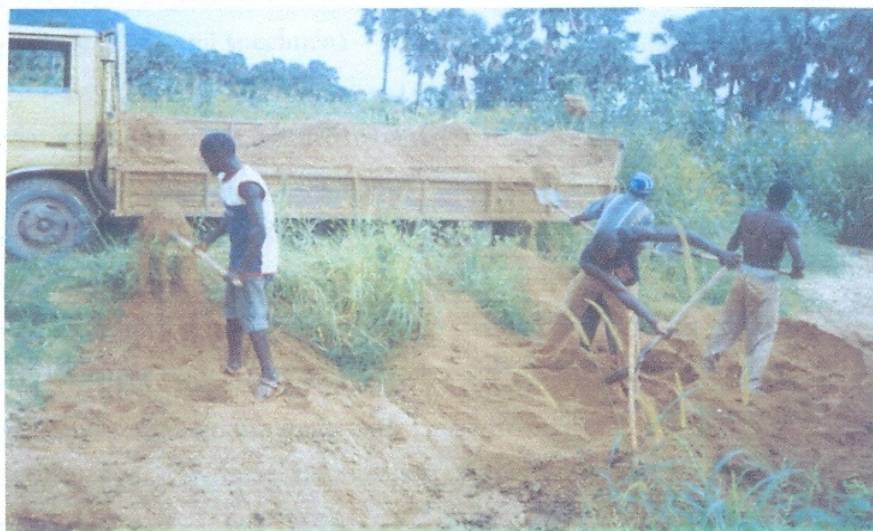
The volumes of soil loss in the gullies range from 697m<sup>3</sup> in Dilguda to 3362m<sup>3</sup> in Gulang Nduson (Table 3). The Bangshika soil is texturally classified as fine to medium loose sandy soil (0.06-0.6mm). Therefore, the soil particles lack sufficient physico-chemical interactions (cohesion) and are free to move hence their high detachability. Once detached they can easily be transported and the process of erosion is then initiated. Bangshika soil with a very low bulk density of about 33.245kg/m<sup>3</sup> is highly detachable, hence highly erodible. The more compacted individual soil particles are, the lesser the tendency for them to be transported and vice versa. Therefore Bangshika soil with a very low particle density of 418.68kg/m<sup>3</sup> has high tendency to be transported hence can be easily eroded. Table 4: Shows the values of Wischmier erodibility indices. They include first approximation of soil erodibility (K') and erodibility factor (K). Values of K ranges from 0.14 to 0.40 with erodibility classes of either low or moderate using bradny (1984) only the soil from Mugadiji shows high erodibility. The higher the percentage pore space of soil, the higher will be the infiltration rate and the higher the infiltration rate the lower will be the run off generation and the lower the run off the lower the tendency of the soil to be eroded. Bangshika soil with percentage pore space as low as 20.60% generates enough run off for considerable water erosion. Table 5: Summarizes the result of aggregate stability and splash detachment. The average number of drops to achieve splash range from 13 in Dilguda to 47 in Gulan Nduson . The aggregate stability range from 6.4 MJ in Dilguda to 23MJ in Mugadiji. Both the splash and aggregate stability are related to soil texture, soils with high clay content had low splash detachment and high aggregate stability while soils with high sand content had high splash values with low aggregate stability. The splash detachment values also reduce with increase in organic matter content. Human Activities: The exploitation of natural resources is a major contributor to erosion in Bangshika area. Beside land use for agricultural purposes, sand collection is a major factor contributing to soil erosion in the study area (Plate 1).

**Plate 1. Sand mining accelerates Gully erosion in the area**

There is need for construction of a dam across Dilguda stream and flood diversion structures around Dakdaba stream. There should be control of sand collection activities in the study area, selection of appropriate land use and filling of gullies.

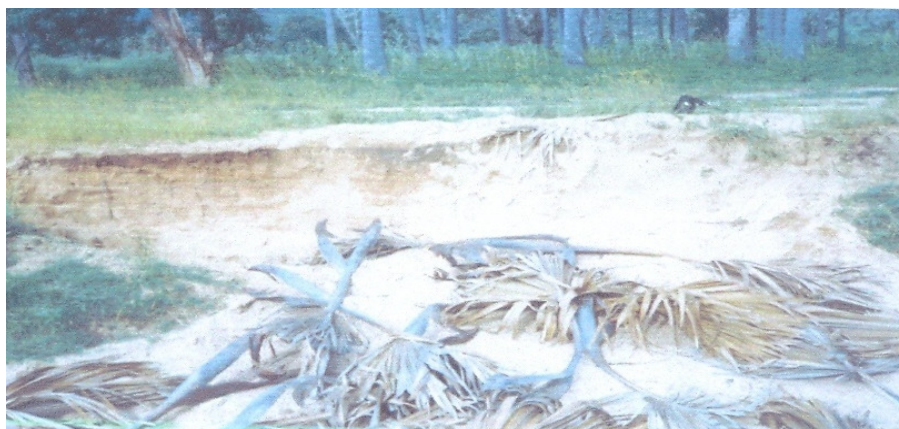
Gully erosion has caused considerable damage to infrastructure, like roads, residential buildings, schools and farmlands in Bangshika and still posing a serious challenge to other arable lands (Plates 2 and 3). Though, the damages caused by this singular phenomenon cannot be easily quantified, but properties worth hundreds of thousands of naira have been destroyed, animals and human lives has been lost to gully erosion in the study area.

**Plate 2: Showing Gully erosion cutting across a road in Lum**

Open drains are required along (on both sides) the road leading to Bangshika from 'Fadamarake'. It should continue along the 'Gashaka' road and discharge to 'River Yau'

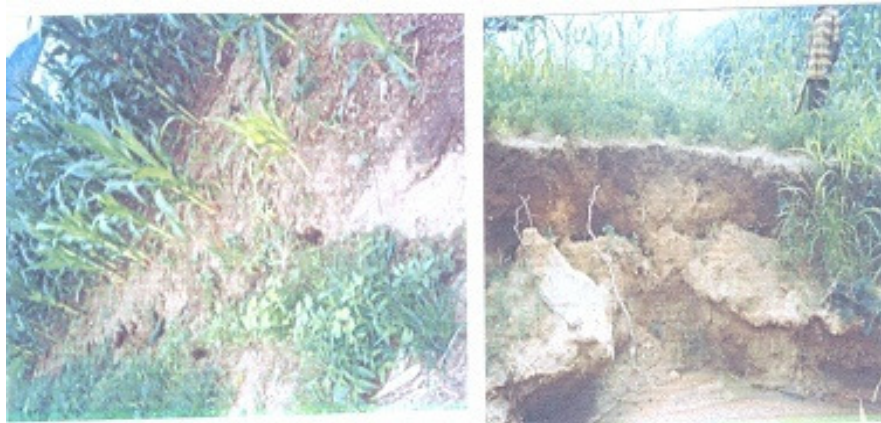
However, from the result of study conducted it showed that 40% of inhabitants of the area have their houses under threat by erosion, while 73% of farmlands in the area are affected by erosion at different stages of development (Plates 3).

**Plate 3: Gully erosion at farm level**

Farmlands and potential arable lands devastated by gully erosion can be improved by filling the gullies with compacted soil mixed with crop residues, sand bags, and gabions. Planting of grasses along natural drainage channels can also help. Good cultural practices that support erosion control like terraces, strip cropping and contouring should be encouraged.
